Manhole Inspection Summary

Manhole # S23C1_003MH

Insp Date: **7/8/08 7:43 AM**

Location Address: **2401 Ridgely St.**

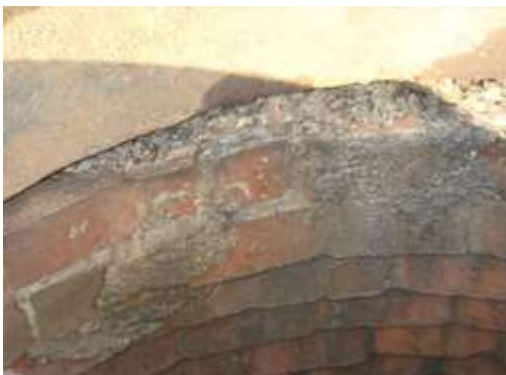
Defect 1

Infiltration: ☐ None ☐ Joint ☐ Cracks ☒ Mortar ☐ Roots ☐ Wall

Infiltration at the frame and chimney joint, because of missing mortar

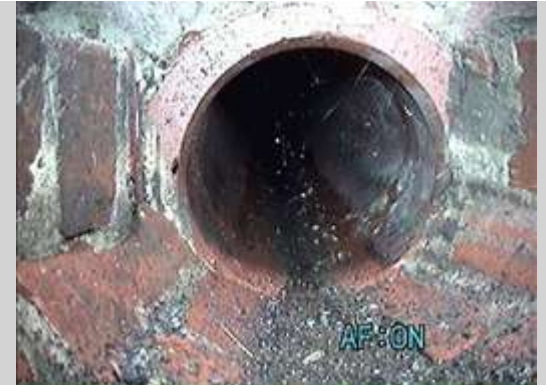
12 O'Clock Outflow

8 in. Circular Gravity Sewer
Pipe Out @ 12 O'Clock

Pipe Height: **8.4** (in.) Rod and Bar (Angled)
Pipe Material: **Clay** ☐ Pipe Lined
Invert Depth: **8.61** (ft.) Flow Characteristics: **None**
Deposits: ☒ None ☐ Mud ☐ Sludge ☐ Debris ☐ Grease
Silt Depth: **0** (in.) Deposits Extent:
Infiltration: **None** Pipe Seal Cond: **Sound**

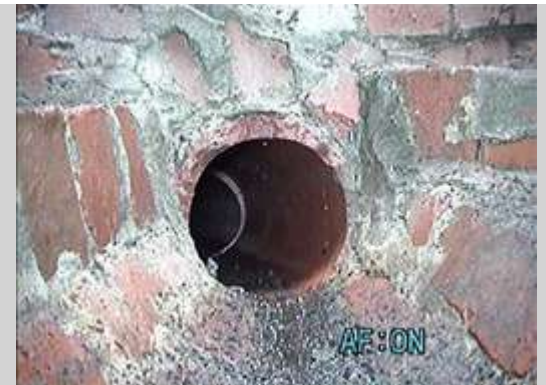
3 O'Clock Inflow

6 in. Circular Gravity Sewer
Pipe In @ 4 O'Clock

Pipe Height: **6** (in.) Rod and Bar (Angled)
Pipe Material: **Clay** ☐ Pipe Lined
Invert Depth: **8.24** (ft.) Flow Characteristics: **None**
Deposits: ☒ None ☐ Mud ☐ Sludge ☐ Debris ☐ Grease
Silt Depth: **0** (in.) Deposits Extent:
Infiltration: **None** Pipe Seal Cond: **Sound**

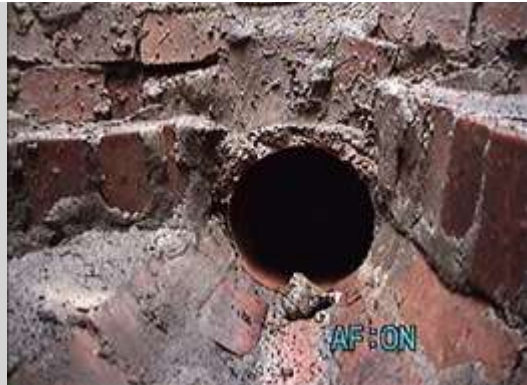
9 O'Clock Inflow

6 in. Circular Gravity Sewer

Pipe In @ 8 O'Clock

Pipe Height: **6** (in.) Rod and Bar (Angled)

Infiltration: **None**

Pipe Seal Cond: **Sound**
